## Steenberg Golf Estate - FINAL Bio-Remediation Report

## Steenberg Estate Golf Club – Bioremediation Report

### Sludge & Water Treatment – (18<sup>th</sup> Hole) Irrigation Dam

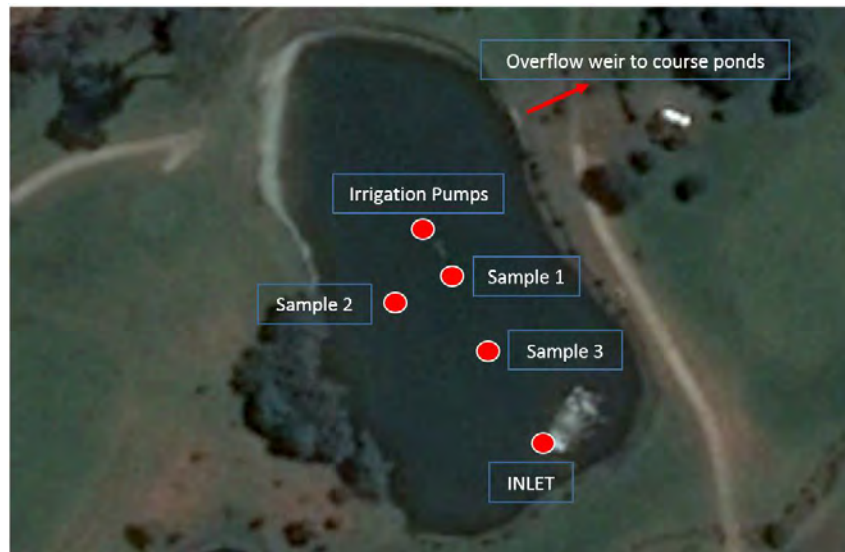
## Sludge Measuring Points

- 3) It was agreed that sludge measurements would be taken at 3 points in the dam, these were taken on a monthly basis.
- 4) Sludge was measured using a sludge tool and was conducted in the presence of Steenberg Estate staff, measurements verified by photographs.

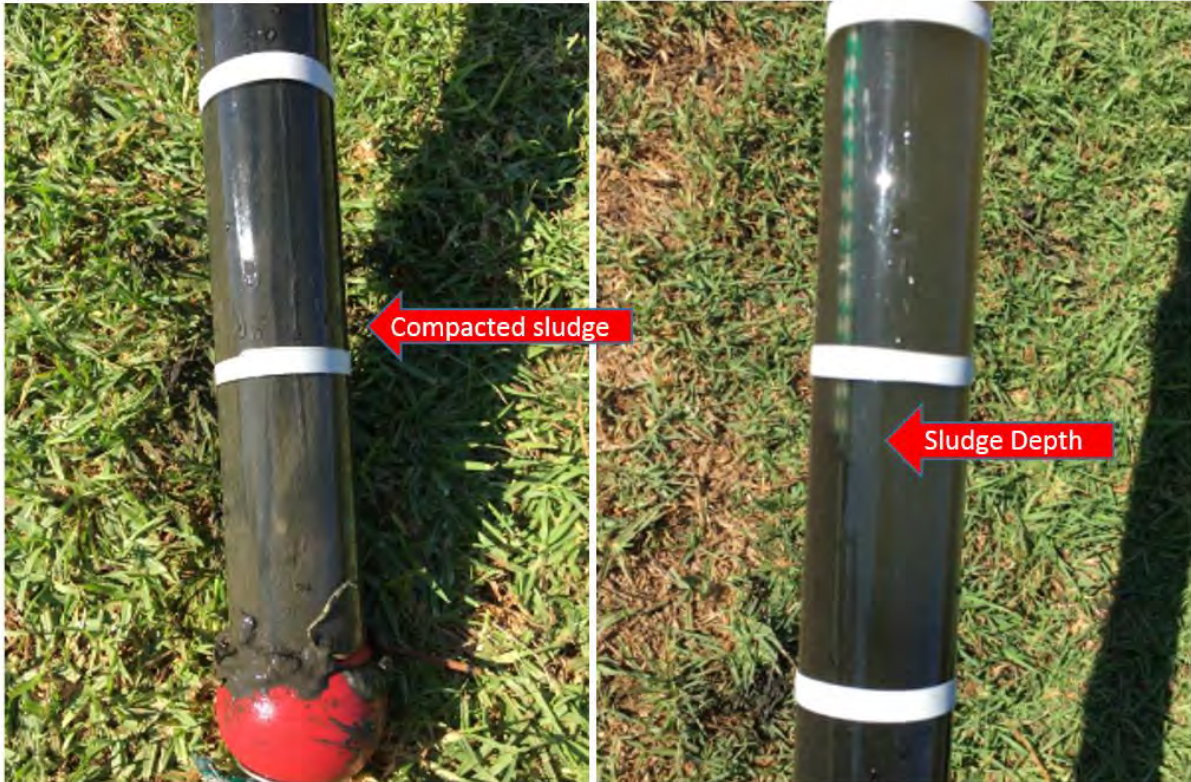
**Sludge Measurement Process Used – Sludge tool with ball**

Compacted sludge serves as plug with rubber ball / Rope becomes visible at top showing sludge level

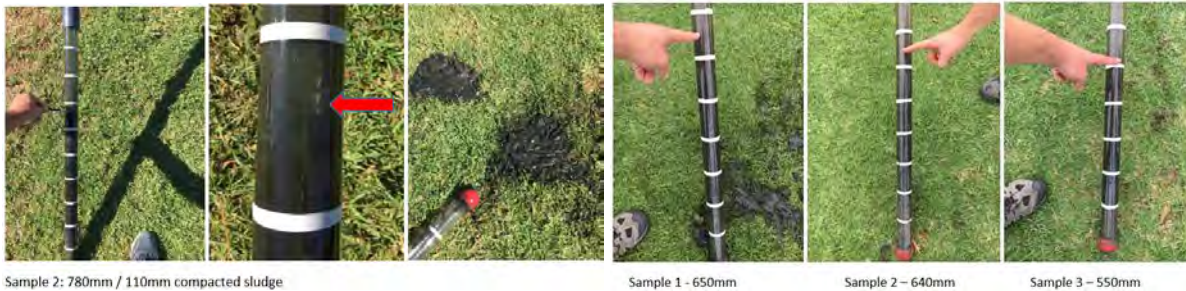
**Measurement Taken 24/3/2016 (Project Start)**

Sample 2: 780mm / 110mm compacted sludge

Sample 1 - 650mm

Sample 2 – 640mm

Sample 3 – 550mm

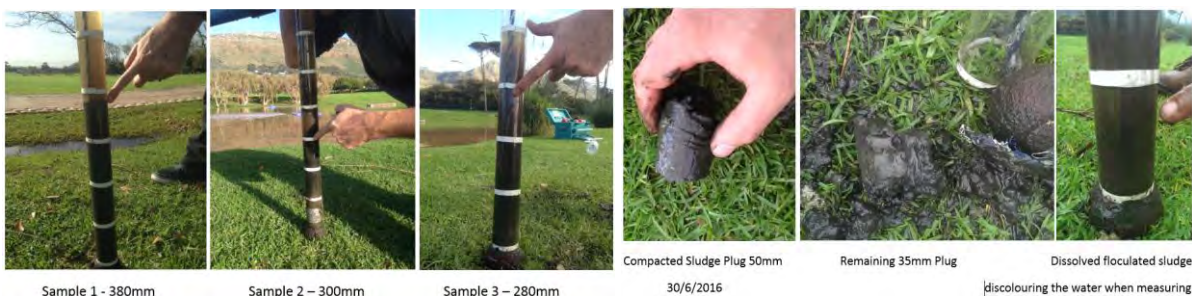
**Measurement Taken 30/6/2016**

Sample 1 - 380mm

Sample 2 – 300mm

Sample 3 – 280mm

Compacted Sludge Plug 50mm  
30/6/2016

Remaining 35mm Plug

Dissolved flocculated sludge  
discolouring the water when measuring
